Manhole Inspection Summary

Manhole # S47K__033MH

Location Address: **2108 boston st**

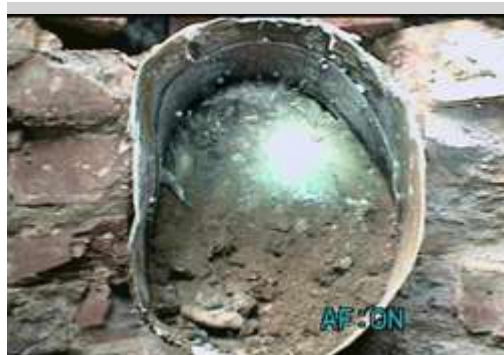
Defect 4

Condition: ☒ Sound ☐ Cracked ☐ Root Intrusion ☐ Deteriorated ☐ Leaks ☐ Debris

channel debris

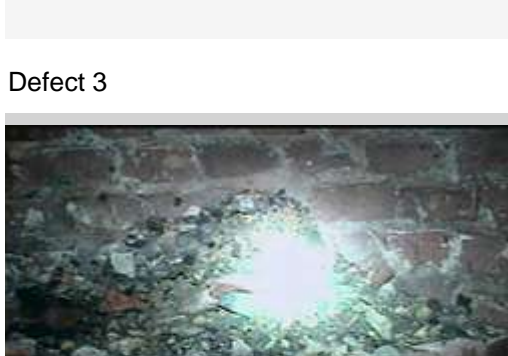
Defect 3

Condition: ☐ Sound ☐ Cracked ☐ Root Intrusion ☒ **Loose Brick** ☐ Deteriorated

Barrel loose bricks

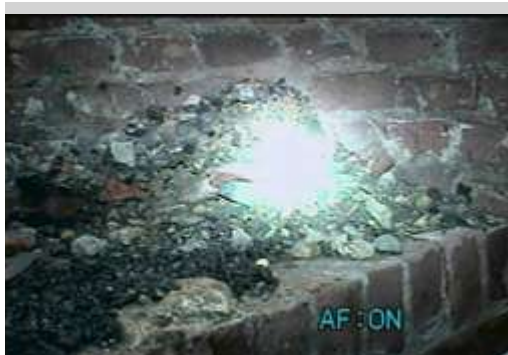
Defect 2

Condition: ☐ Sound ☐ Cracked ☐ Root Intrusion ☐ Deteriorated ☐ Leaks ☒ **Debris**

bench debris

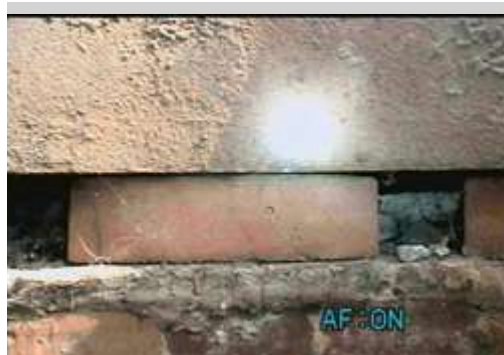
Defect 1

Condition: ☐ Sound ☒ **Cracked** ☐ Root Intrusion ☒ **Loose Brick** ☐ Deteriorated

chimney loose bricks, cracked, frame adj

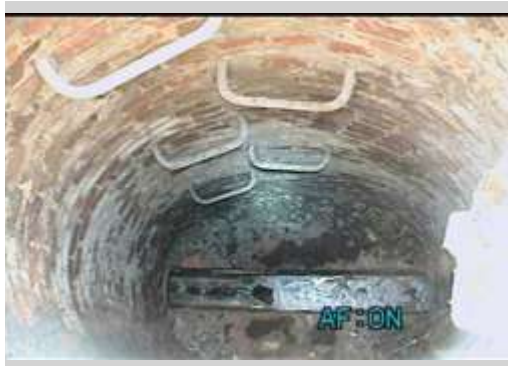
Count: **5** Missing: **0** ☒ **Corroded**

steps

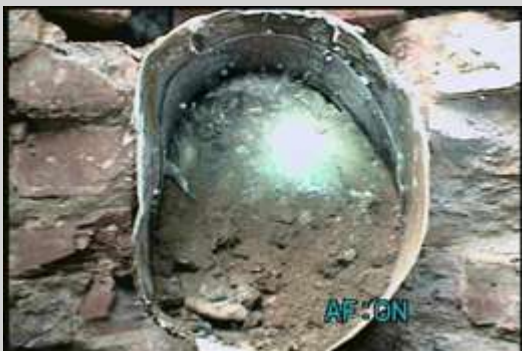
6 O'Clock Inflow

upper pipe @ 6 closed
